Samos-Sığacık Earthquake Highlights the Importance of Multi Hazards and Physics Based Ground Motion Modelling

**Eser aktı, Boğaziçi University
and Tomorrow's Istanbul**

Tomorrow's Cities Comment 09

24/02/21

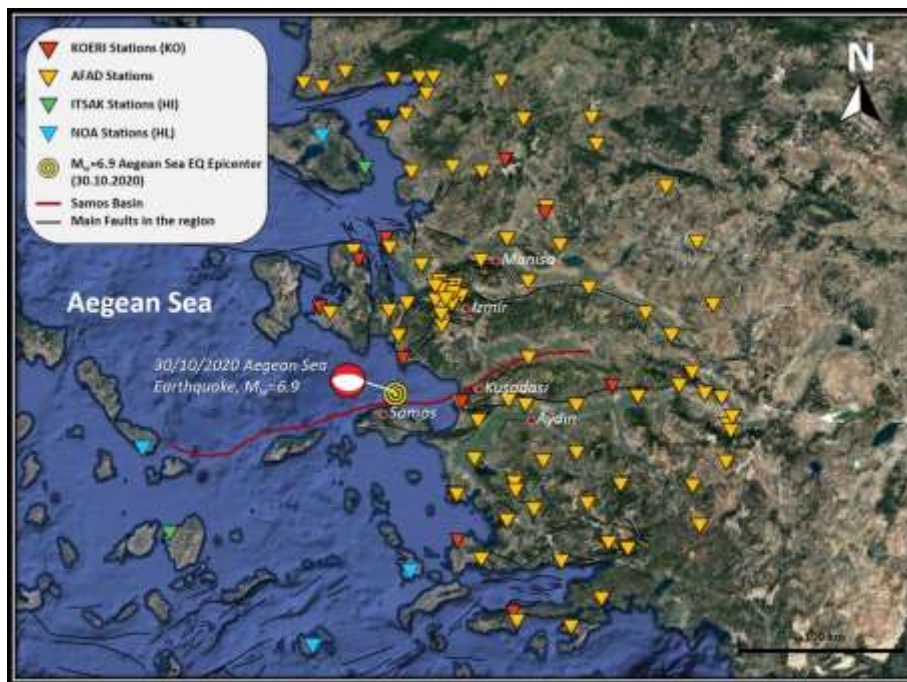
Figure 1. 30.10.2020 Samos-Sığacık earthquake, strong motion stations in the region and hard-hit localities. (Fatma Sevil Malcioğlu, BÜ)

The Mw 6.9 earthquake that took place offshore between the Greek island of Samos and Turkey's İzmir province on 30 October 2020 didn't come as a surprise (Figure 1 by F.S. Malcioğlu, BÜ, Animation 1 by Dr. M. Çağlar, BÜ). Due to the extensional tectonic regime of the Aegean and high deformation rates, earthquakes of similar size frequently occur in the Aegean Sea on fault segments close to the shores of Turkey, affecting the settlements on mainland Turkey and on the Greek Islands. Since 2012, five earthquakes of magnitudes 5.7 and above were strongly felt and caused damage (10.6.2021 Fethiye Mw 6.1; 8.1.2013 offshore Çanakkale Mw 5.7; 24.5.2014 off shore Gökçeada Mw 6.9; 12.6.2017 offshore Karaburun Mw 6.2; 21.7.2017 Bodrum Mw 6.6). The Samos-Sigacik earthquake had a normal faulting mechanism, as almost all regional earthquakes do. It was recorded by the strong motion networks in Turkey and Greece (Figure 1). The recorded levels of ground motion were more or less in line with those expected from an earthquake of this size and so was the damage (<https://eqe.boun.edu.tr/en/30-october-2020-1451-aegean-sea-izmir-mw69-ml66-earthquake-preliminary-assessment>).
